## 4. Exploded View

Indoor Unit  
36k

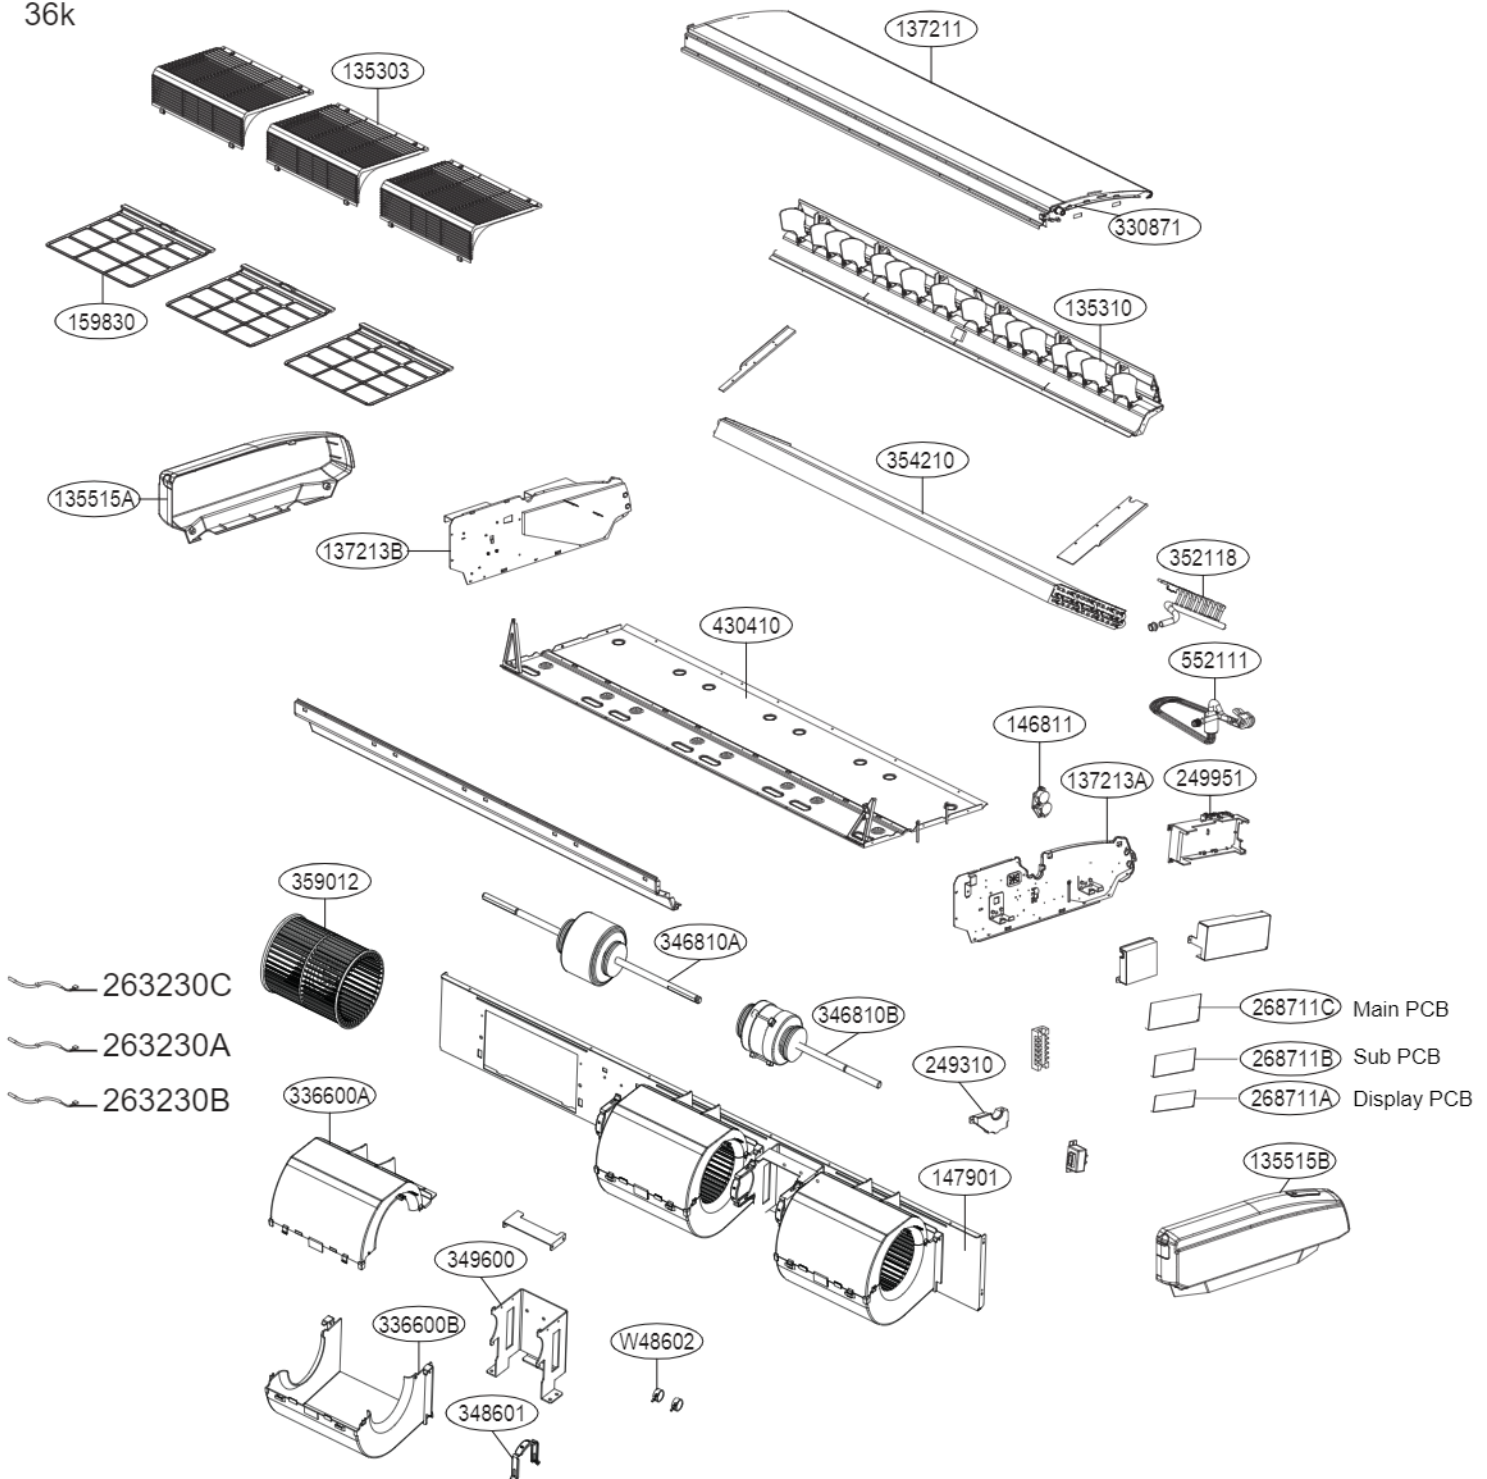
| Thermistor 1 | 263230C | Air | Housing color : yellow |
| Thermistor 2 | 263230A | Eva. In | Housing color : white |
| Thermistor 3 | 263230B | Eva. Out | Housing color : red |
