## 5. Exploded View

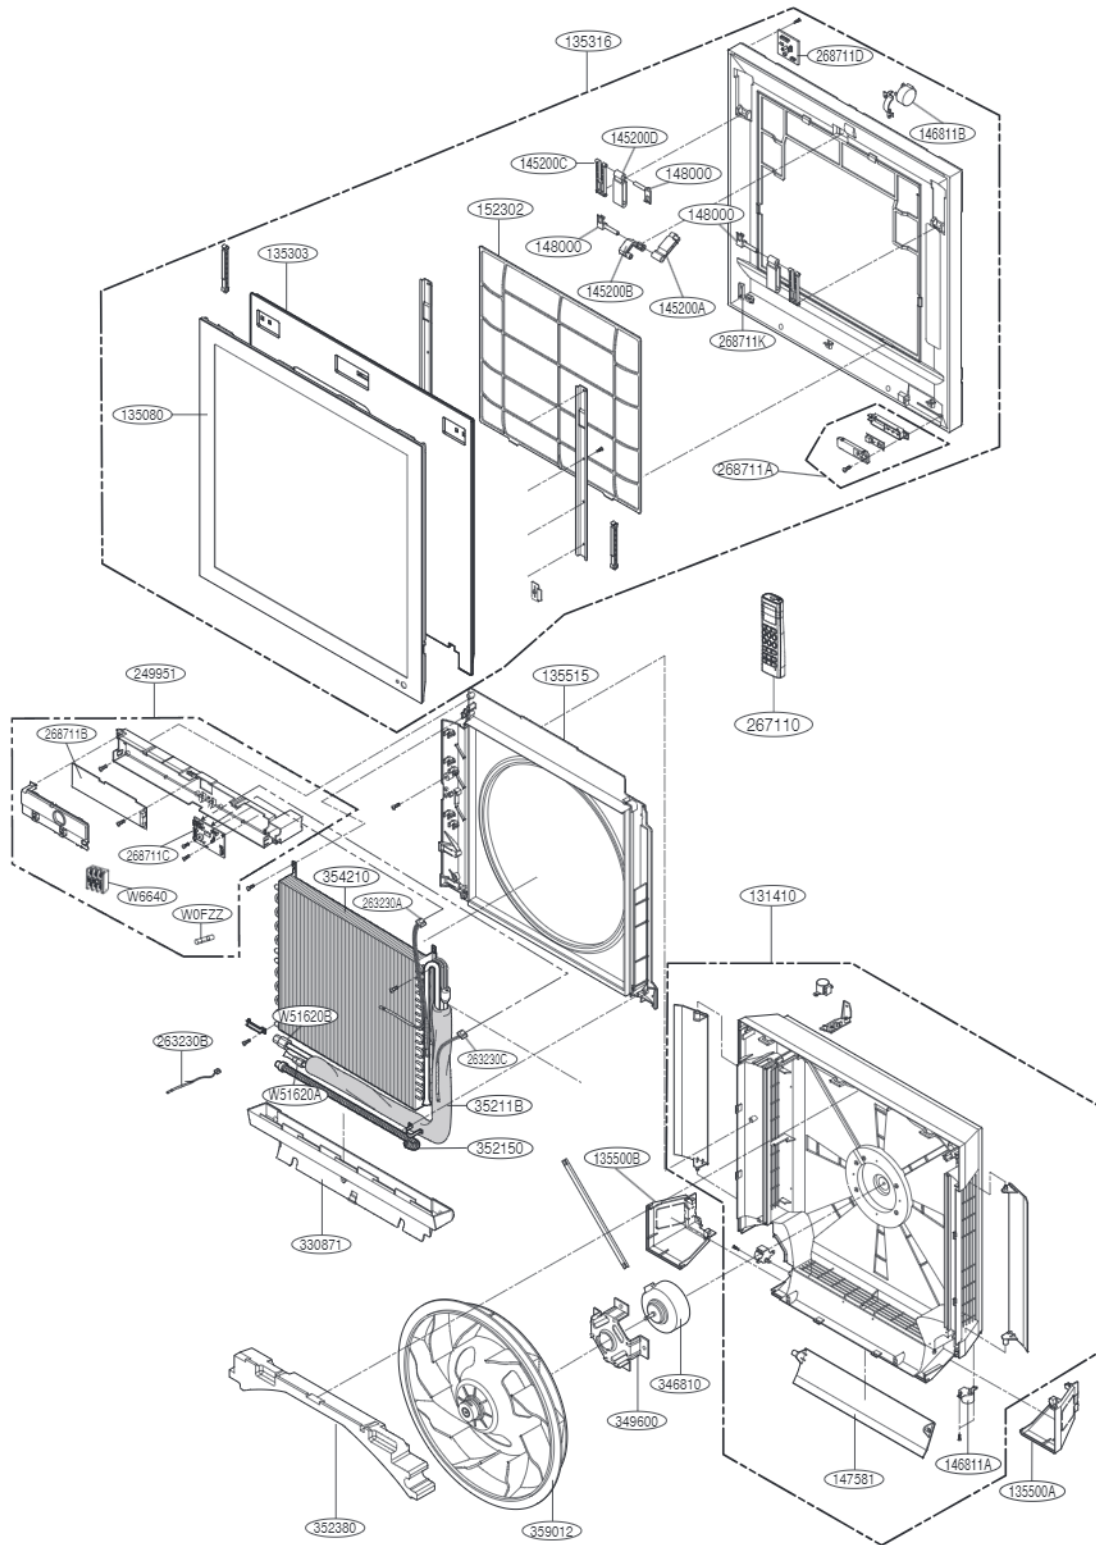
Thermistor 1	263230A	Air	Housing color : white
Thermistor 2	263230B	Eva. In	Housing color : white
Thermistor 3	263230C	Eva. Out	Housing color : red
